# Cincinnati Central School Long Range Facilities Plan (LRFP)

May 23, 2012

# Cincinnati Central School - Long Range Facilities Plan

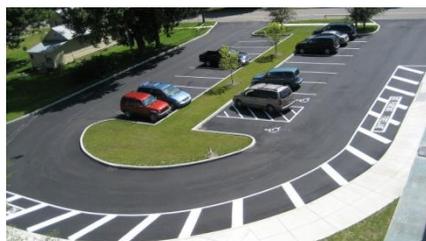
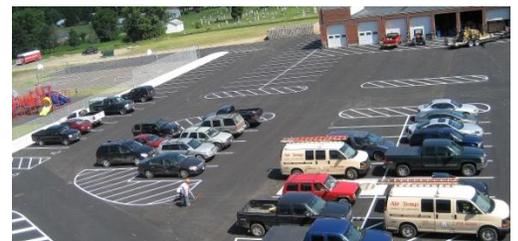
3. #40 Main Building - Re-seal Parking Lot, including Bus Loop area - \$15,000.00

Original 2008 parking area needs to be maintained by re-sealing all pavements.

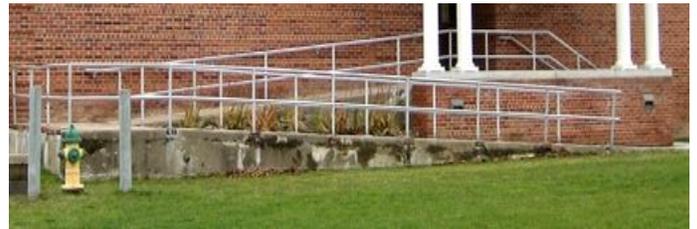
10. #65 Main Building - F-Wing Handicap Ramp Removal - \$30,000.00

This Handicap ramp is no longer required and has deteriorated. Need to remove this ramp.

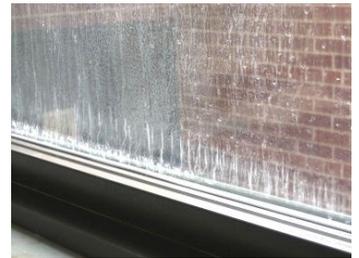
11. #67 Main Building - Windows need replacement glass, lost their seal - \$15,000.00  
Failing seals on 1985 window panes need to replace window glass with new.

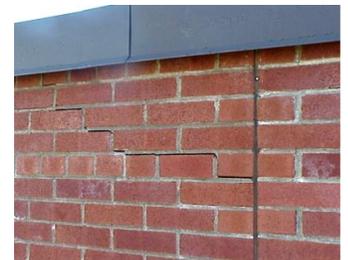
20. #61 Main Building - Remaining Masonry Restoration - \$100,000.00

Certain exterior areas of the building are in need of restoration because of years of building movement.

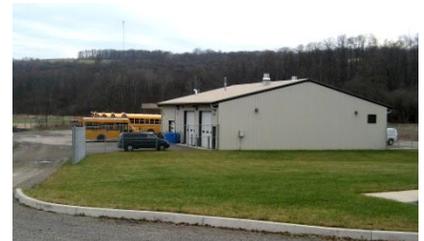
38. #40 Transportation Facility - Driveway/ Parking Lot Pavement - \$500,000.00

Current driveway is made from tar and stone. Need to pave this drive area and the bus parking area.
